Manhole Inspection Summary

Manhole # S13GG_025MH

Location Address: **2919 PRESBURY ST**

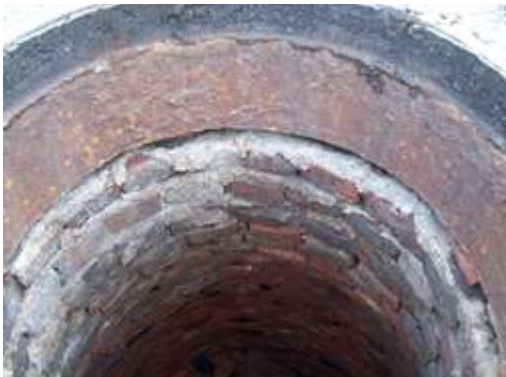
Defect 2

Condition: ☐ Sound ☐ Cracked ☐ Root Intrusion ☒ **Loose Brick** ☐ Deteriorated

CHIMNEY LOOSE BRICKS

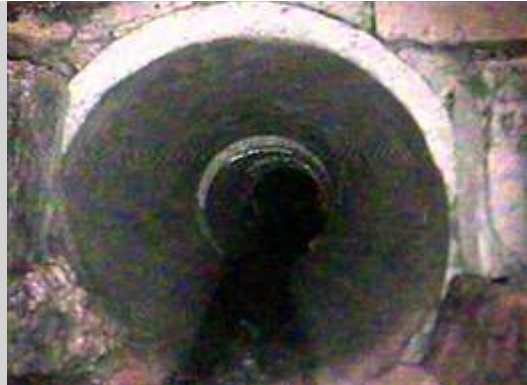
12 O'Clock Outflow

8 in. Circular Gravity Sewer
Pipe Out @ 12 O'Clock

Infiltration: **None** Pipe Seal Cond: **Sound**

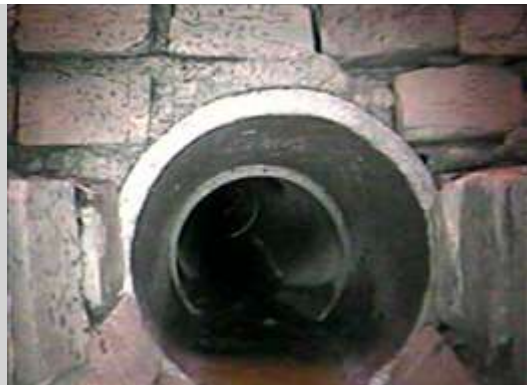
3 O'Clock Inflow

8 in. Circular Gravity Sewer
Pipe In @ 3 O'Clock

Infiltration: **None** Pipe Seal Cond: **Sound**

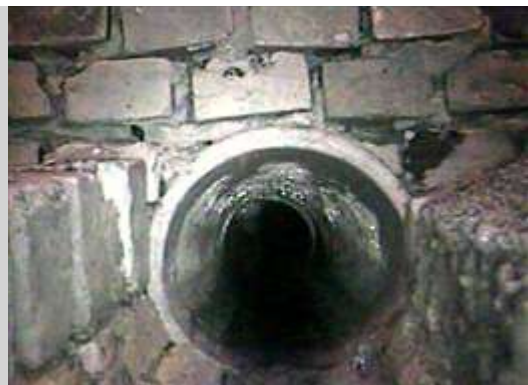
6 O'Clock Inflow

8 in. Circular Gravity Sewer
Pipe In @ 6 O'Clock

Infiltration: **None** Pipe Seal Cond: **Sound**
